Structural Evaluation of the Stay Cables of the Luling Bridge

Louisiana Department of Transportation and Development

Construction Technology Laboratories, Inc.

Wind-Induced Vibration of Cable Stay Bridges
2006 Workshop, St. Louis, MO, April 25-27

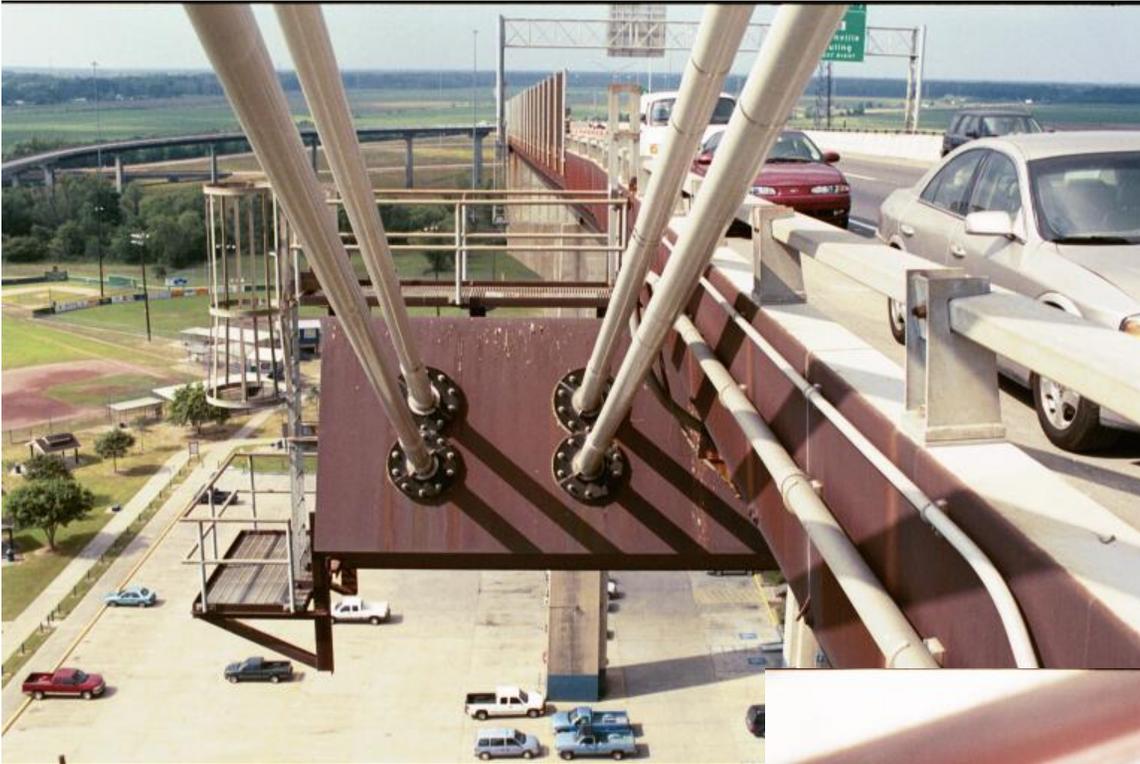
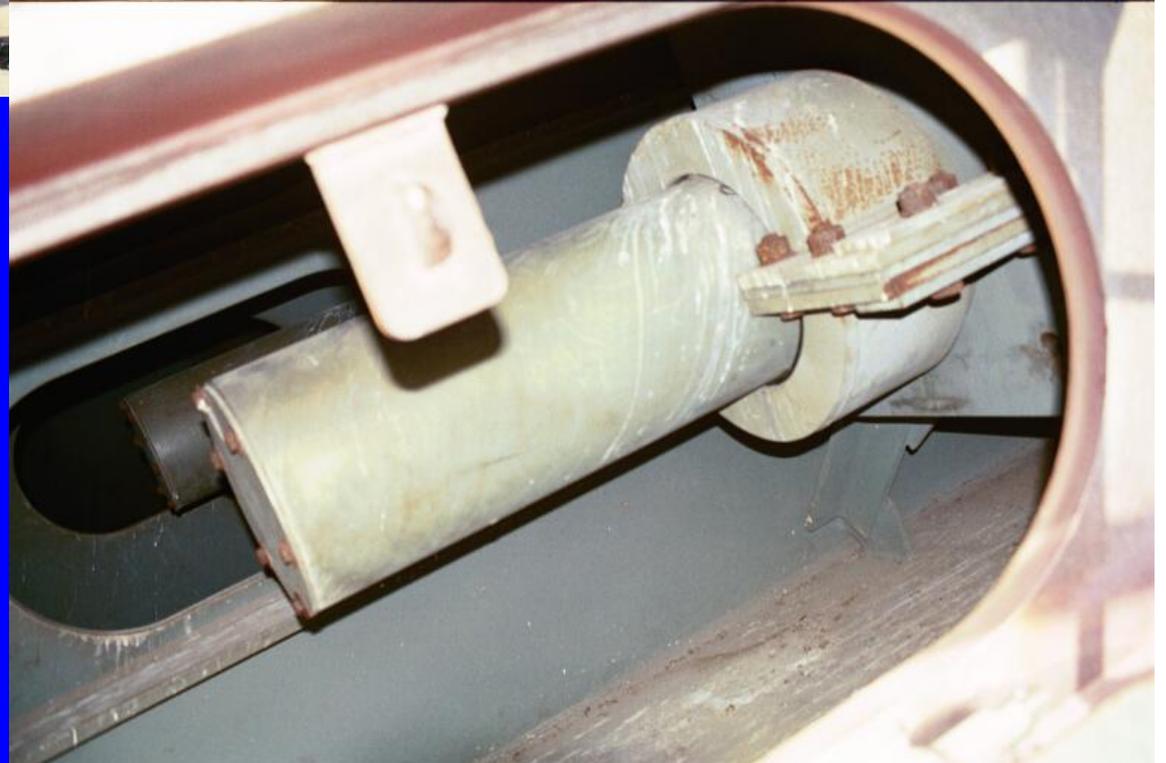
Lower Anchorage

- Rusting and water leakage in the anchorage zones at the deck level was reported
- Splitting of cable cover pipes had occurred during grouting process
- Unplugged grout ports were observed
- These are symptomatic signs of potential compromise in the safety of cables
- In 2002, LADOTD awarded CTLGroup a project for Structural Evaluation of the Stay Cable Array

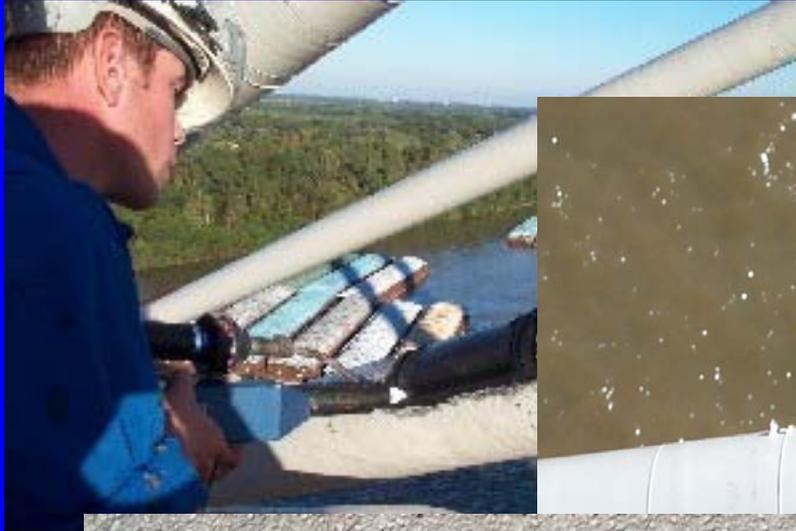
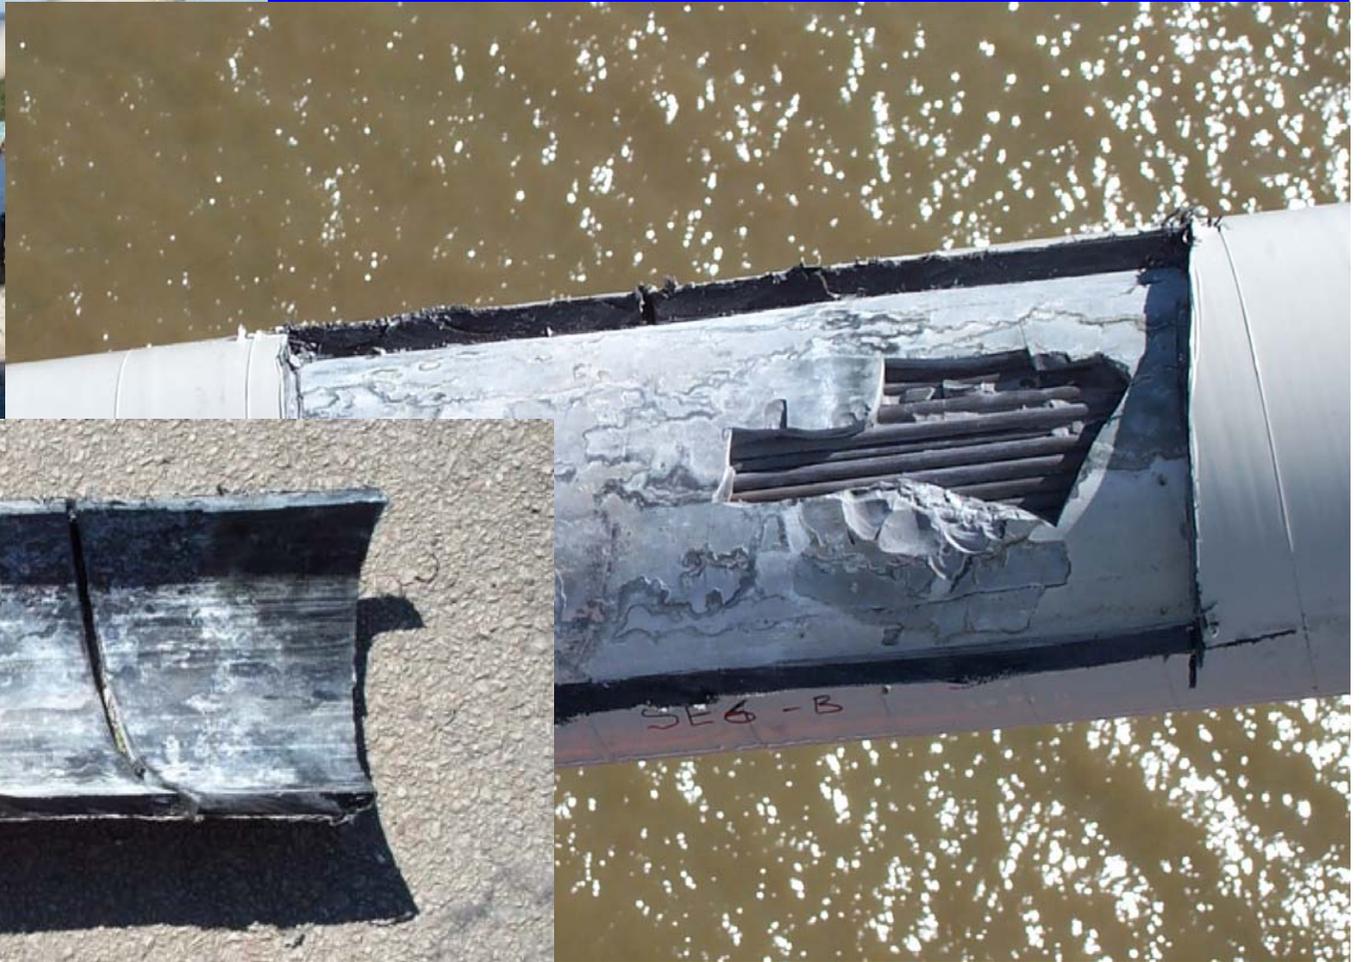
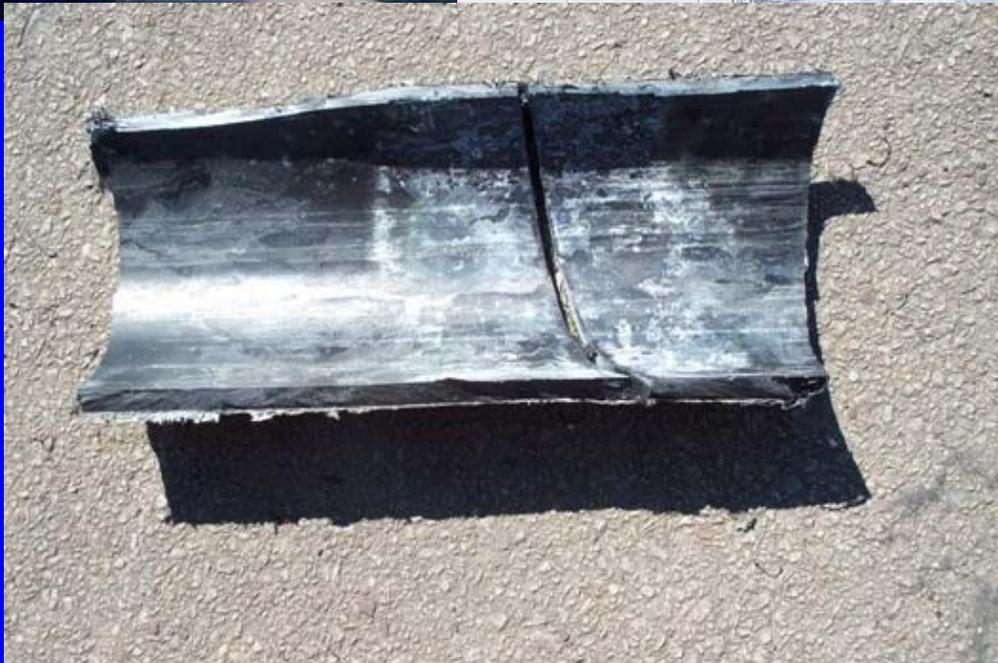
Cable Dissection

- Corrosive Environment in the lower anchorage zones
- Damaged seals- aging and vibration
- Progressive deterioration in PE split and repaired locations
- Potential for progressive PE split
- Potential for excessive cable vibration
